# **QUILEUTE TRIBAL SCHOOL**

**Asbestos**

**Location Details**

**February 28, 2017**

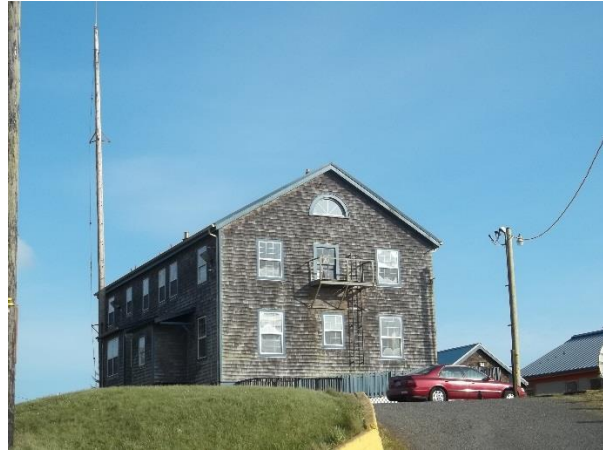
**Old Administration Building (101T) - looking East**  
Testing confirmed portions of building contain asbestos.

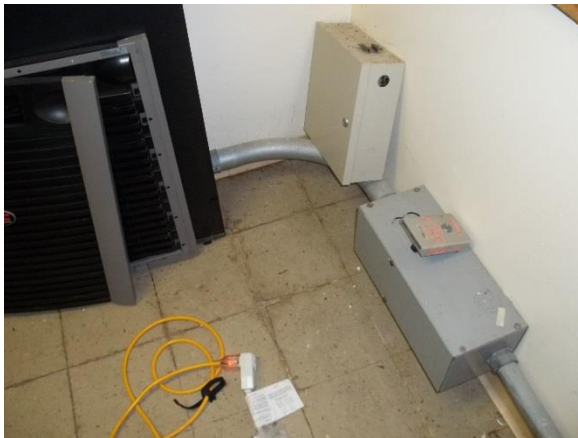
**Old Administration Building (101T) – SW Corner Basement Office 6**  
[9" floor tiles and mastic of 3% Chrysotile]

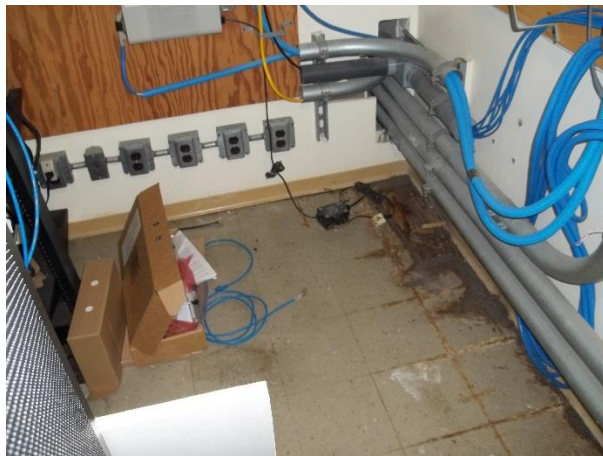
**Old Administration Building (101T) – SE Corner Basement Office 6**  
[9" floor tiles and mastic of 3% Chrysotile]

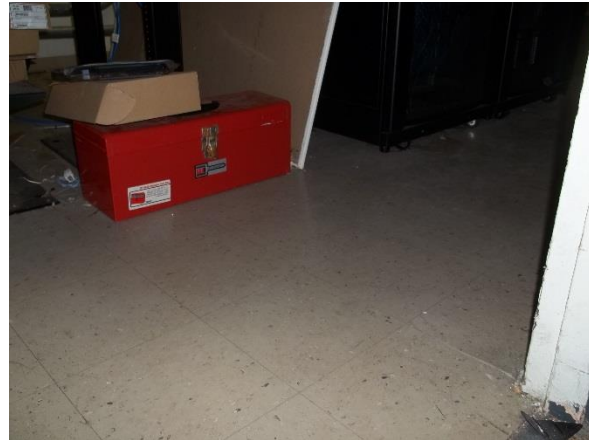
**Old Administration Building (101T) – Basement  
Office 6**

View is looking at floor in through the doorway  
into the phone equipment room.  
[9" floor tiles and mastic of 3% Chrysotile]

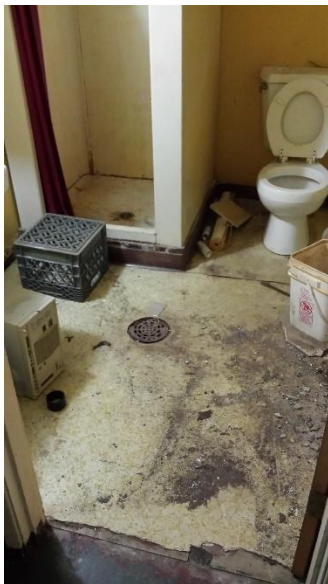
**Old Administration Building (101T) – Old  
Basement Restroom 5**

[Area confirmed to contain asbestos in  
WAT 07-29-2016 sample.]

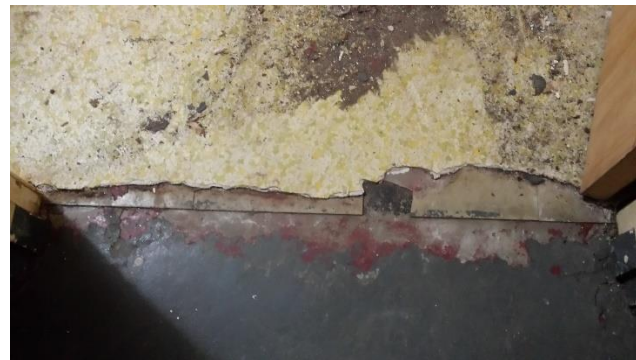
**Old Administration Building (101T) – Restroom  
5 Doorway Layer Detail**

[9" gray floor tiles and mastic of 2% and 4%  
Chrysotile, respectively. Yellow vinyl is non-  
asbestos containing per WAT 07-29-2016  
sample.]

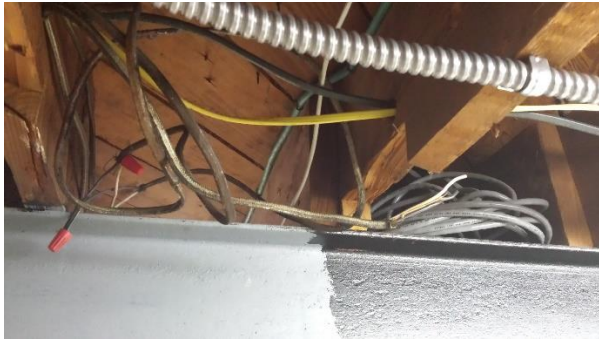
**Old Administration Building (101T) – Outside Restroom 5**

View is looking up at the area where WAT Sample #4 was taken – a non-asbestos wire sample.

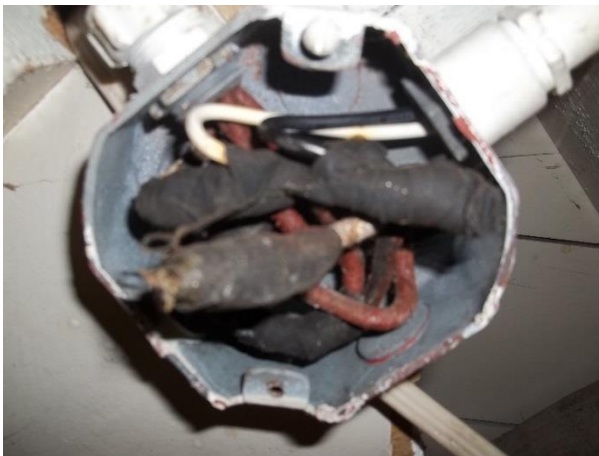
**Old Administration Building (101T) – Sample of Old Basement Office Wiring on West End**  
[Area of possible asbestos containing material]

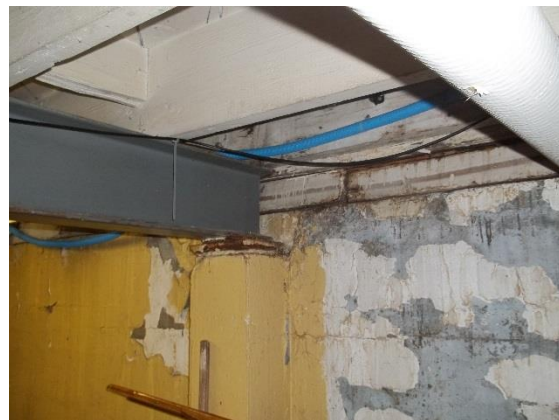
**Old Administration Building (101T) – Sample of Old Basement Office Wiring**  
[Area of possible asbestos containing material]

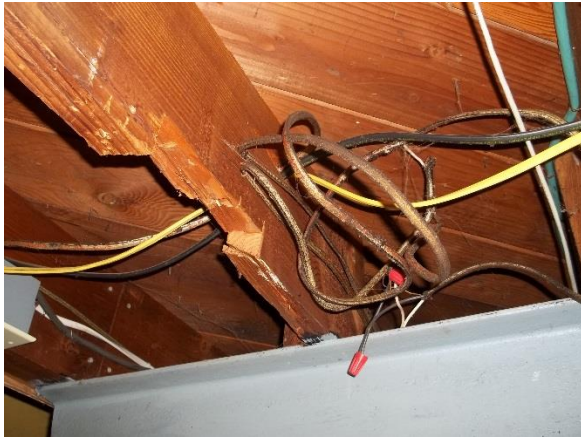
**Old Administration Building (101T) – Sample of Old Basement Office Wiring on West End**  
[Area of possible asbestos containing material]

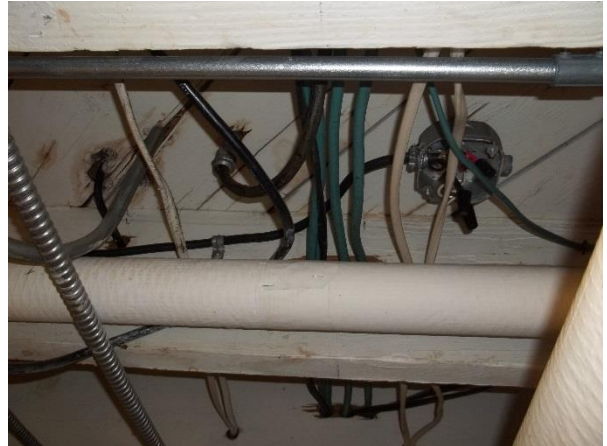
**Old Administration Building (101T) – Sample of Old Basement Office Wiring on East End**  
[Area of possible asbestos containing material]

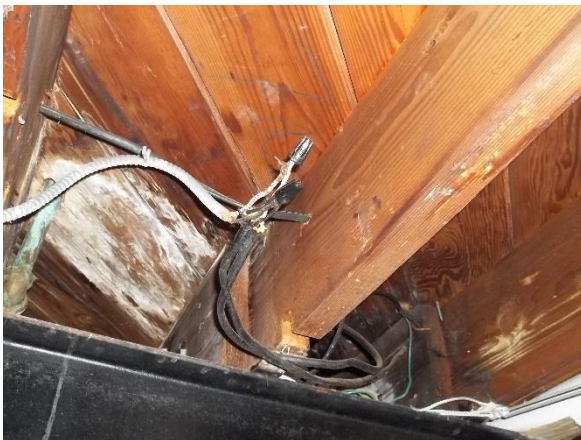
**Old Administration Building (101T) – Sample of Old Basement Office Wiring on West End**  
[Area of possible asbestos containing material. WAT 07-29-2016 sample indicated non-asbestos material for a single non-energized wire that is part of picture.]

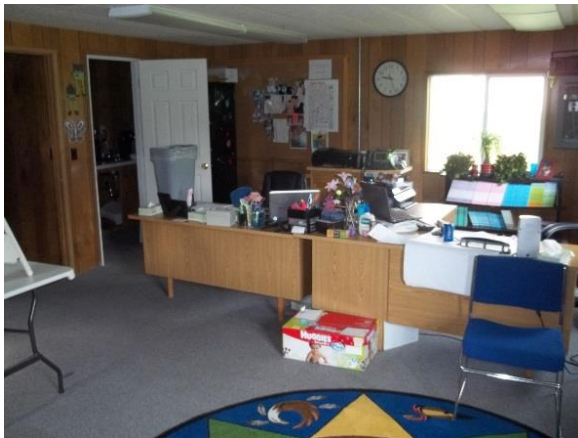
**Culture Building (102T) – Classroom 5**  
Original floor covering has been hidden by wall-to-wall carpet.  
[Sheet vinyl flooring with 30% Chrysotile]

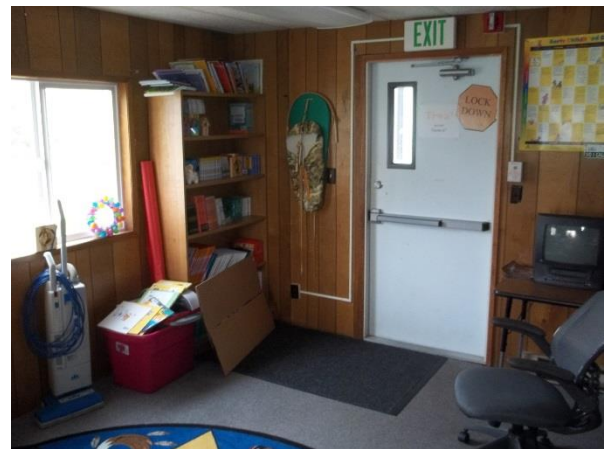
**Culture Building (102T) – NE Corner of Classroom 5**  
Original floor covering has been hidden by wall-to-wall carpet.  
[Sheet vinyl flooring with 30% Chrysotile]

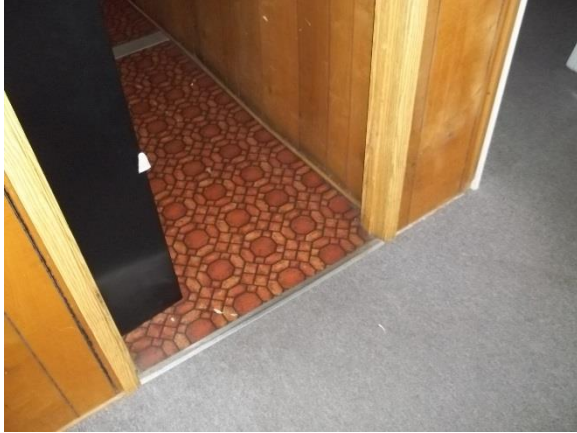
**Culture Building (102T) – Hallway to Classroom 5**

Original floor covering has been hidden by wall-to-wall carpet in classroom and hallway is original material.

[Sheet vinyl flooring with 30% Chrysotile]

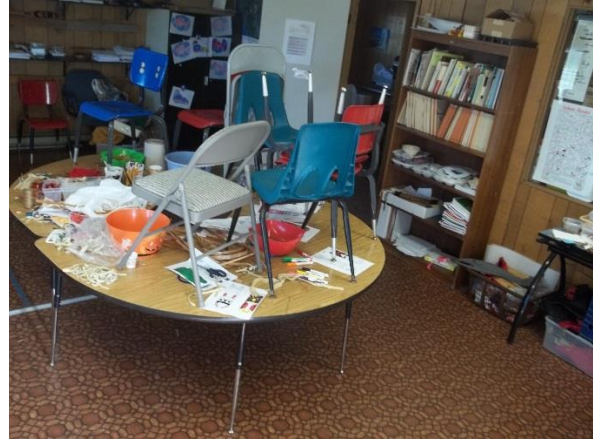
**Culture Building (102T) – NW Corner of Classroom 1**

This is original floor covering.

[Sheet vinyl flooring with 30% Chrysotile]

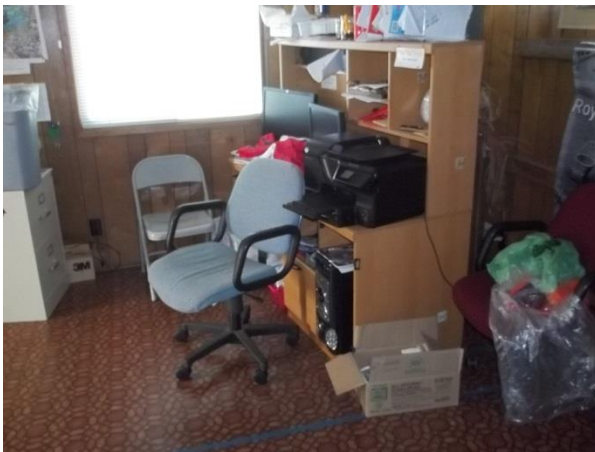
**Culture Building (102T) – SW Corner of Classroom 1**

This is original floor covering.

[Sheet vinyl flooring with 30% Chrysotile]

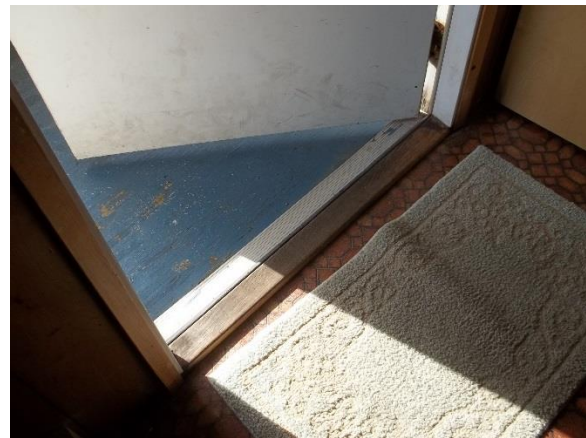
**Culture Building (102T) – Exit Doorway from Classroom 1**

This is the original floor covering covered by a throw rug.

[Sheet vinyl flooring with 30% Chrysotile]

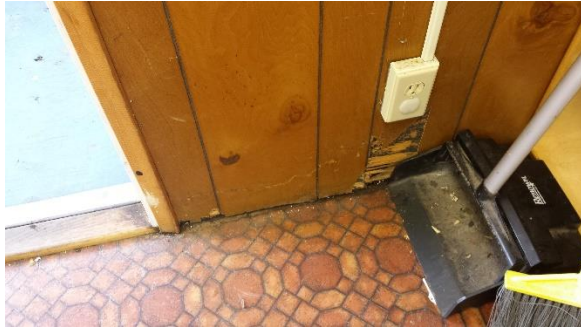
**Culture Building (102T) – SE Corner Doorway  
Detail in Classroom 1**  
Original floor covering with trim removed and  
no apparent damage.  
[Sheet vinyl flooring with 30% Chrysotile]

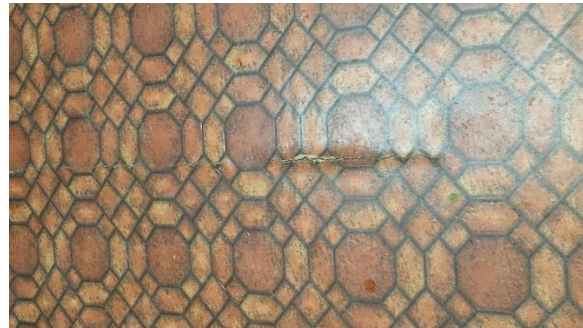
**Culture Building (102T) – Floor Covering  
Crack Detail in Classroom 1**  
This is original floor covering.  
[Sheet vinyl flooring with 30% Chrysotile]

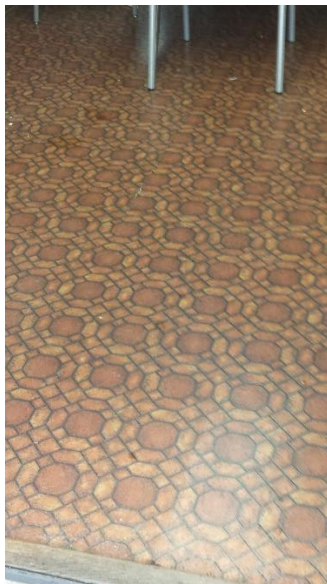
**Culture Building (102T) – Floor Covering  
General Area of Crack in Classroom 1**  
This is original floor covering.  
[Sheet vinyl flooring with 30% Chrysotile]

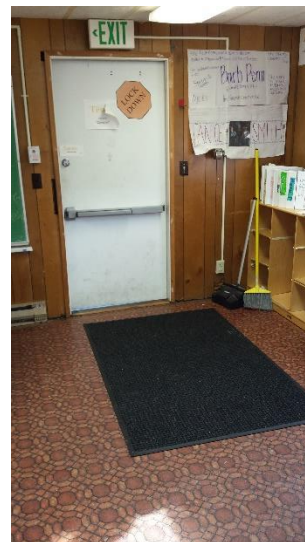
**Culture Building (102T) – Exit Doorway from  
Classroom 1 with Rubber Floor Mat  
Covering Damaged Floor**  
[Sheet vinyl flooring with 30% Chrysotile]

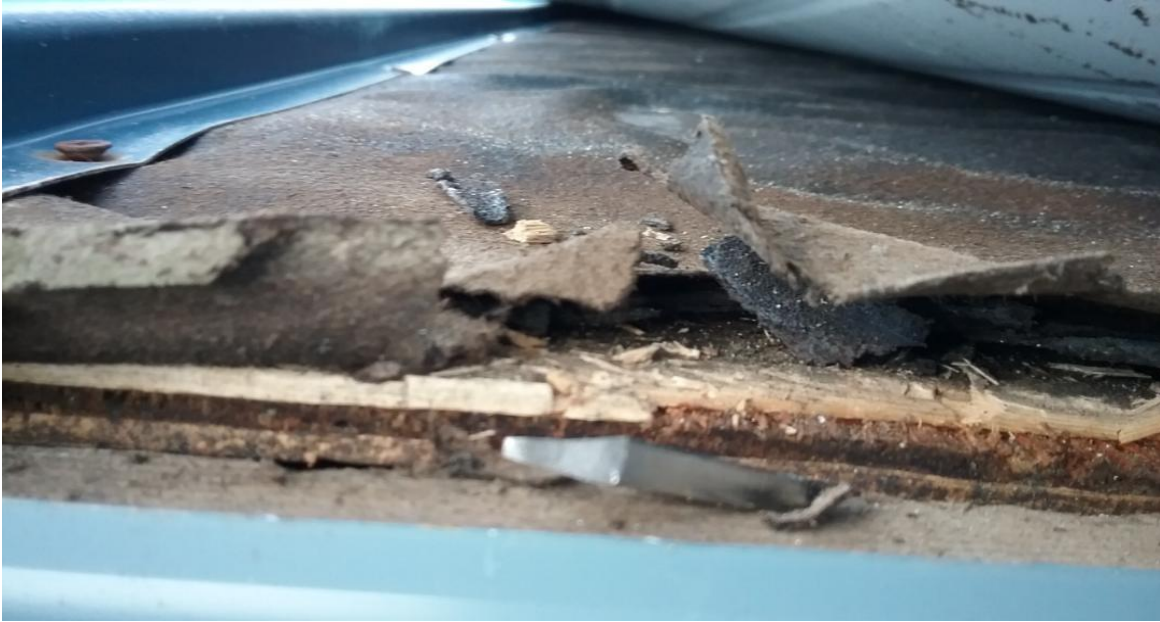
**Culture Building (102T) – N end of Building, Exterior Roof Decking on Portable  
(now covered by second metal roof)**

Original roof covering with some obvious damage – Covered/enclosed by second roof.  
[Black asphaltic roofing material with 4% Chrysotile. Material confirmed to contain asbestos  
in WAT 02-27-2017 sample. ]

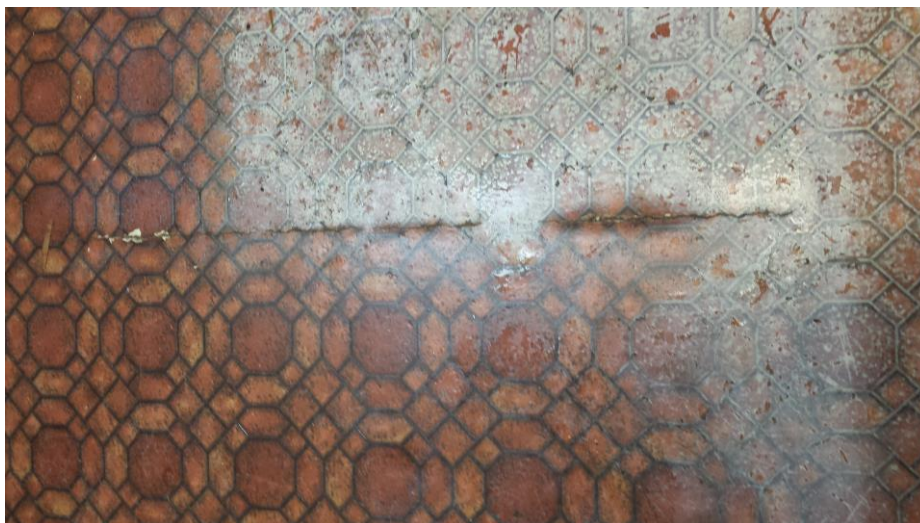
**Culture Building (102T) – Floor Covering Showing Expansion of Crack in Classroom 1**

This is original floor covering and the picture was taken on January 30, 2017.

[Sheet vinyl flooring with 30% Chrysotile]
